RECALL ACTION BULLETIN

Number: RC 002

Model: MG TF

MG TF front lower suspension ball joint rivet
check / replace

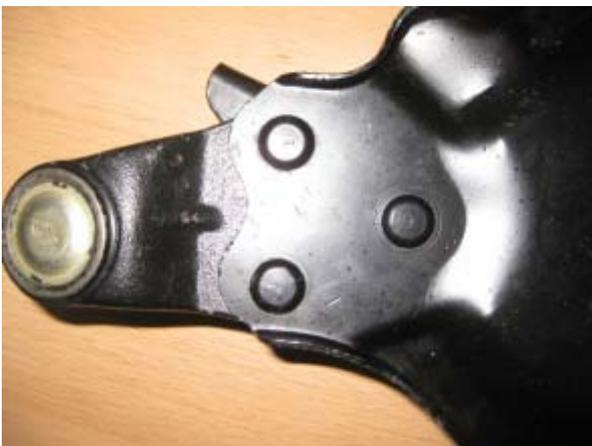
Fig. 1

Fig.1 - Shows lower front arm with mild steel black painted rivets with flat head finish. Also note the black painted ball joint

5. If one or both front lower arm rivets are identified as being of mild steel construction please carry out the below action:

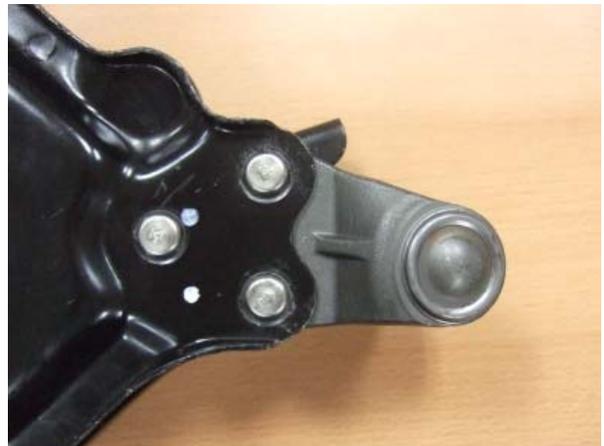
Fig. 2

Fig 2. – Shows lower front arm with stainless steel rivets with domed head finish. Also note unpainted ball joint

4. IF both front lower arms rivets are stainless steel add Yellow a paint spot to the R/H (off side) inner wheel arch adjacent to the horns and above the E mark label as shown below.

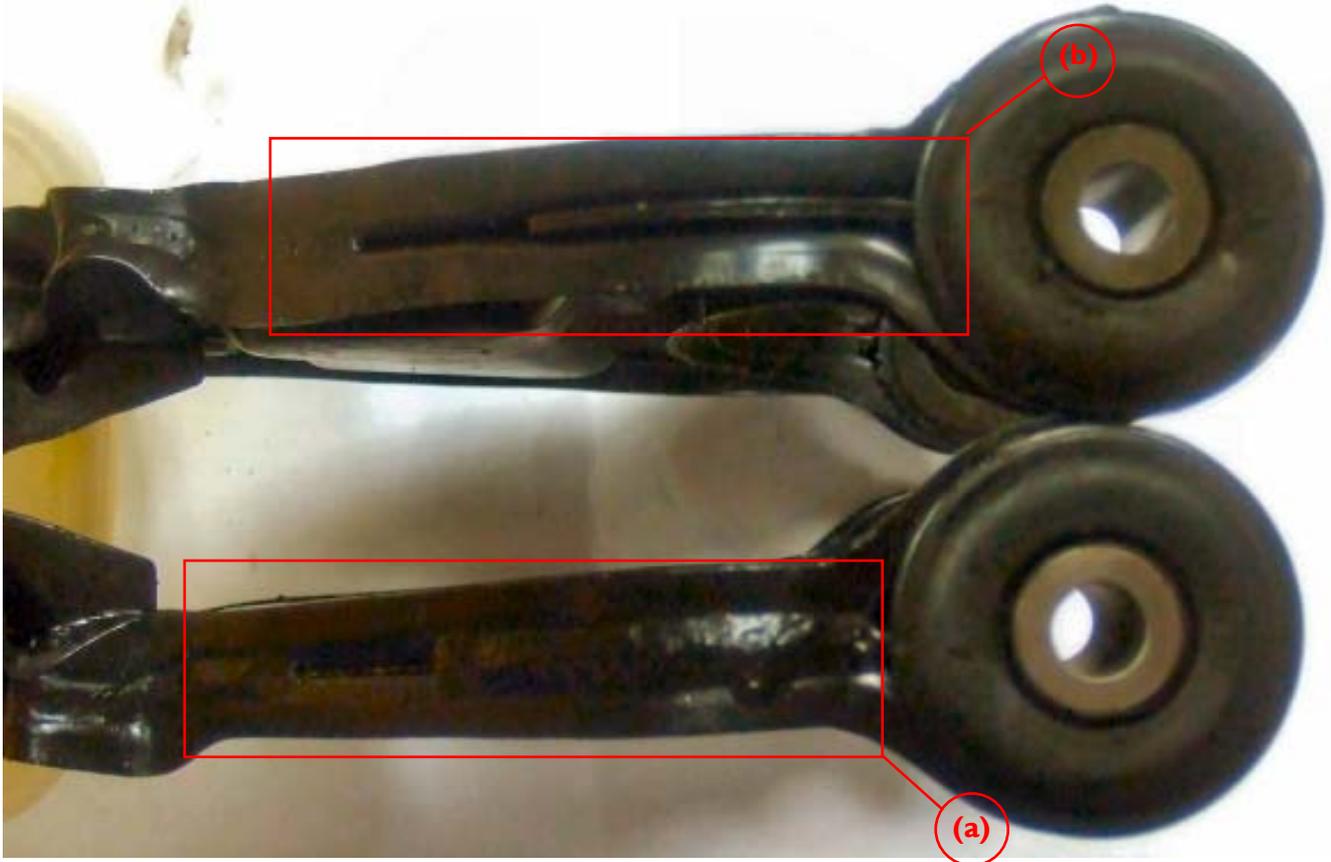
Fig. 3

One additional visual difference as shown in Fig 3 is that the lower arm fitted with mild steel rivets has a seam welded joint (a) whereas the lower arm fitted with stainless steel rivets has a sandwich construction (b).
