RECALL ACTION BULLETIN

Number: RC 002

Model: MG TF

MG TF front lower suspension ball joint rivet
check / replace

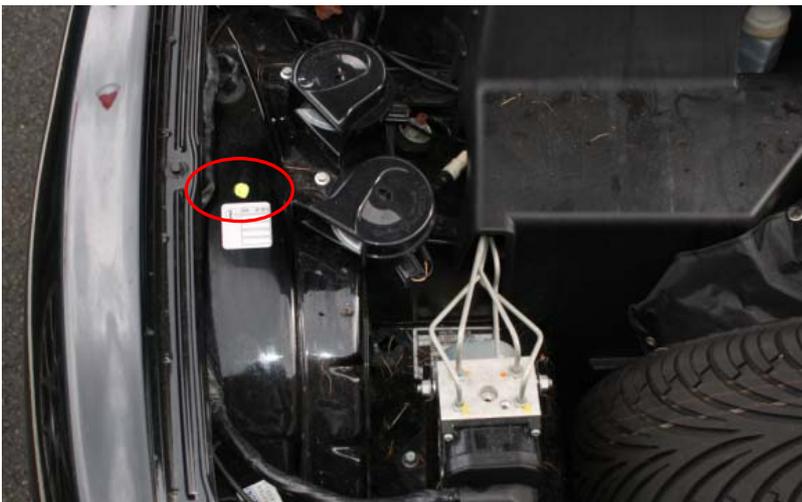
1. Open the bonnet, check for Yellow paint spot on the R/H (off side) inner wheel arch adjacent to the horns and above the E mark label as shown below. If the paint mark is present **NO FURTHER ACTION IS REQUIRED**. If the paint mark is not present please follow the content of this Recall Action Bulletin.
